MANDAN WALKABILITY ASSESSMENT 2023

Final Report

January 2024

Prepared by:
Kim Riepl
Bismarck-Mandan Metropolitan Planning Organization
Bismarck, ND

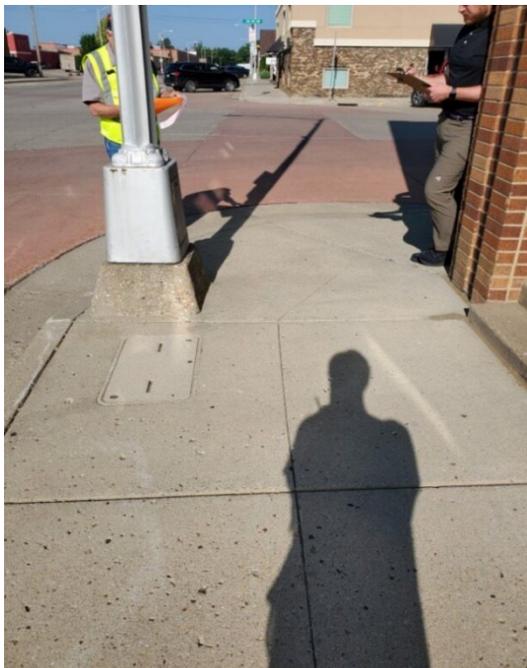
This intersection was found to be good overall, with some room for improvement. Roadways comprising this intersection are all two-way, two-lane with diagonal on street parking and absence of designated bicycle lanes or facilities. Posted speed limit of 25mph seemed to be somewhat obeyed by the drivers observed. Lighting at the intersection appeared to be adequate. East/west traffic on 1st St NW is free flowing while north/south traffic on 3rd Ave NW has stop control. Diagonal parking and placement of the stop sign on the sidewalk make it difficult for motorists to see. Sidewalk widths in this area were sufficient when taken from building edge to inside of curb. However, there were instances of sign or light pole placement which restricted the

accessible area of the sidewalk. The concrete sidewalk was found to be generally level and in overall good condition without substantial cracks or raised sections.

Future improvements at this intersection, which has a wide crossing area of approximately 60-feet, should include enhancements like raised curb bulb outs, additional high visibility

crosswalk markings, or parking restrictions on crosswalk approach. There may be an option of placing stop signs and lighting in bulb outs to remove impediments from sidewalks and to increase visibility of stop signs.

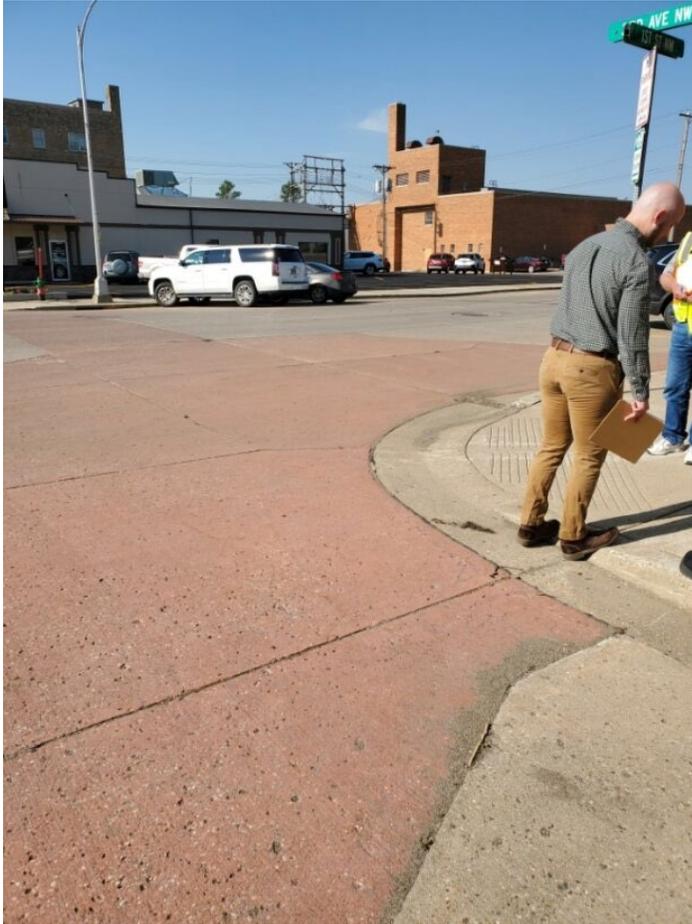
The intersection featured colored bulb outs and crossing area throughout. ADA ramps are present on all four legs of the intersection, and each have tactile ground surface indicators for pedestrians with visual impairments; however, there are no truncated domes. The bottom of the ramp opens to a diagonal crossing of the intersection rather than to the desired perpendicular crossing of the roadway. Visually impaired individuals following the direction of the ramp opening may find themselves in the middle of the four legs of the intersection traffic rather than crossing the street as intended.

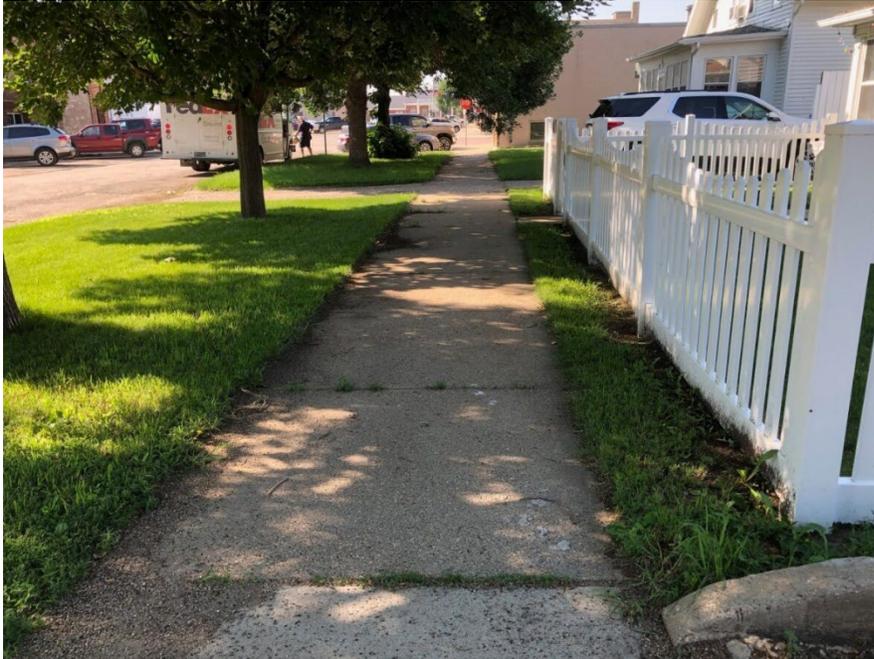
Initially, the segment was quite walkable, with 72" concrete sidewalks which, once beyond the commercial area and walking through the residential area, were separated from the roadway with an approximate 18' grass covered boulevard. This boulevard provides sufficient area for shade trees. It is assumed it would also be used by property owners for snow storage in the winter months, assisting with maintaining clear sidewalks for walking. The sidewalks here were

in good condition, level and of a consistent material with no missing segments. Additionally, driveways intersecting with the sidewalks were predominantly level with the sidewalk. The photo (left) shows an area of pleasant walking conditions with excellent fence placement to foster a feeling of security for passing pedestrians without encroaching on the usable sidewalk area.

One assessor commented this is an example that could be used for any homeowner interested in making front yard enhancements.

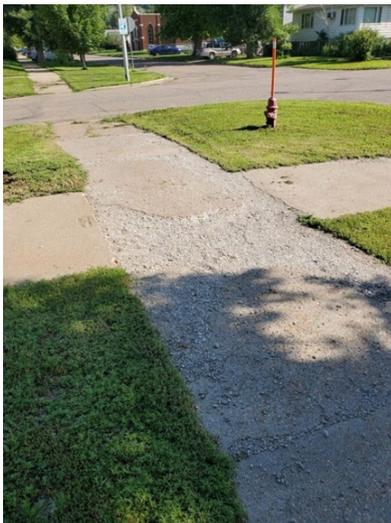
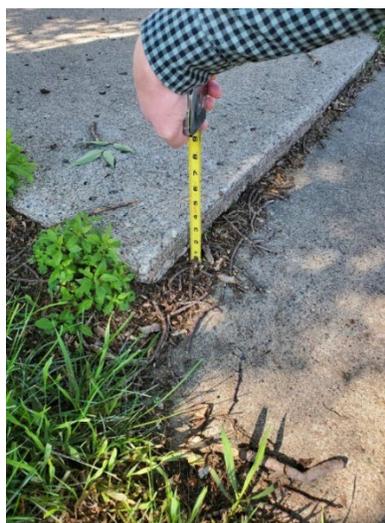
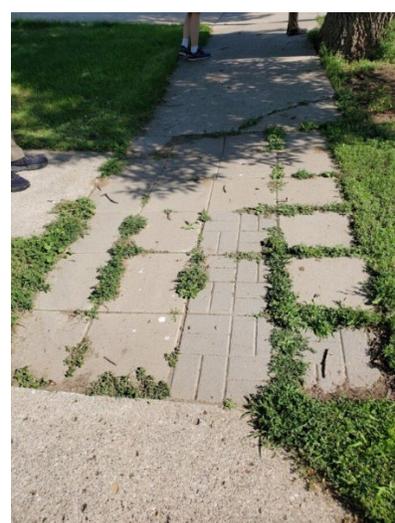
The walkability level soon deteriorated and became more difficult. The surface condition of the sidewalk was predominantly poor, displaying an inconsistency in materials used and overall poor surface condition. There was cracking, pitting, flaking, and heaving observed, with vegetation growing up through the sidewalk. (see photos, below)

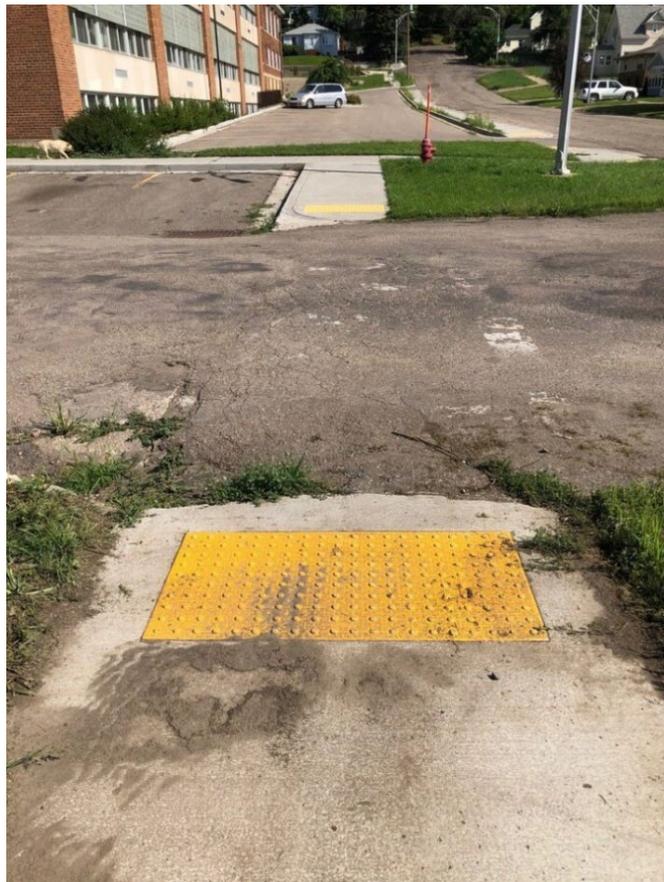
The photo to the right shows the intersection of 3rd Ave NW and 4th St NW, looking north toward the redeveloped Mandan Junior High School, which is now the Historic Apartments on Fourth. Efforts to improve this crossing have been made with the installation of a high visibility truncated dome pedestrian tile. This pad is ADA compliant and beneficial to visually impaired pedestrians. There is also evidence of some possible pavement markings in the crossing area, but they are so diminished that it is hard to determine whether they are the remnants of crosswalk markings or a stop bar, as there is a side street stop sign located here. (It is notable that the sidewalk facility on the north side of 4th Street has been entirely replaced and includes ADA compliant truncated dome tiles at the sidewalk where it meets the crossing area of the intersections as can be seen in the photo.) Also demonstrated in the photo is the rise of the road where it meets the sidewalk. This is due to the asphalt overlay situation previously described and results in the same issues of inefficient storm water and runoff drainage, erosion and vegetation growth, and a transition from sidewalk to roadway that contributes to collection of debris, making this area difficult to navigate.

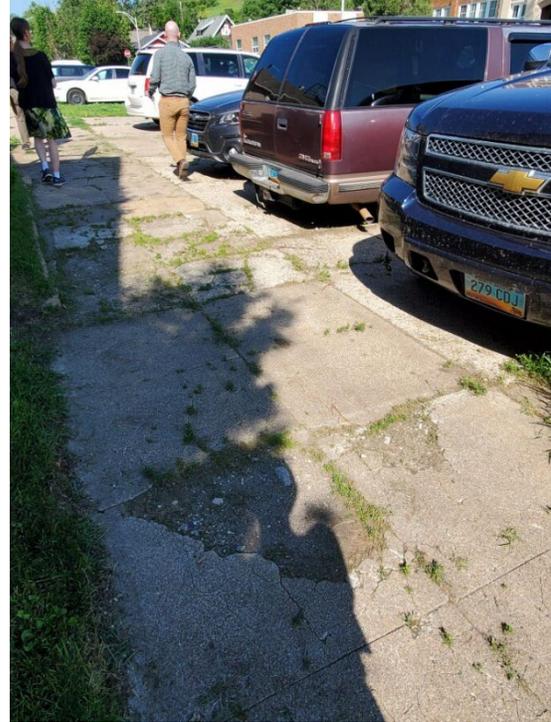
Many challenges to pedestrian accessibility, comfort, and safety were encountered. Shown here is the perpendicular parking of vehicles immediately adjacent to the sidewalk, common to this segment of the audit route. This type of parking lacks any barrier between the pedestrian and the moving vehicle, presenting a safety issue with vehicles pulling into park, whether driving forward or backing in as shown in the photo. Bollards or some form of barrier should be installed to prevent vehicles from parking on the sidewalk, which was also observed, and to protect sidewalk users. It may be possible for the City to codify regulations to address this issue as part of their parking ordinance.

Additionally, the sidewalk was in very poor condition, with heaving, cracking, and breaking throughout. Broken segments exposed the dirt underneath and scattered rock and debris, along with the uneven surface and vegetation cropping up in places, made walking very difficult.

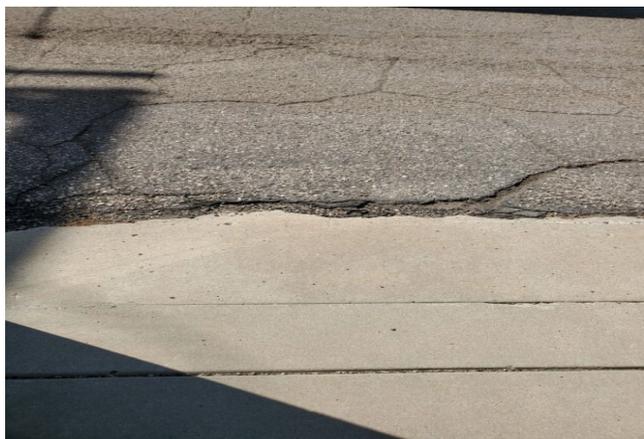
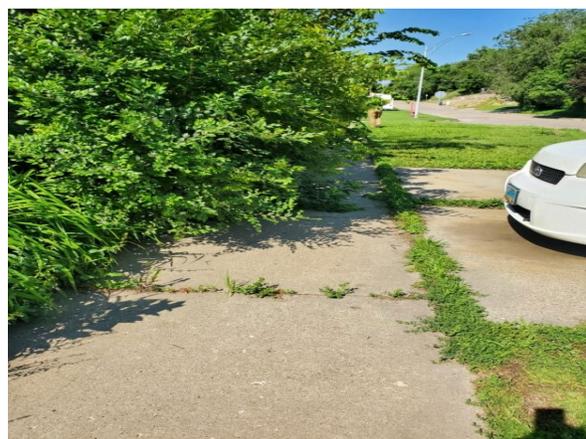
The photos below show the mid-block ally (*below, left*) displaying the same asphalt overlay pavement issue as the streets in the area and overgrown vegetation (*below, right*) which has rendered the sidewalk impassable. Again, there may be opportunity to involve the public works department to help prevent the latter with formal policy development and enforcement.

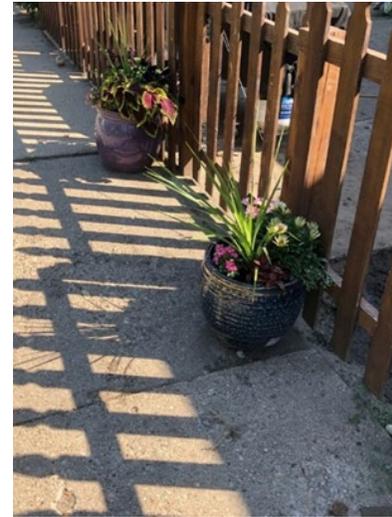
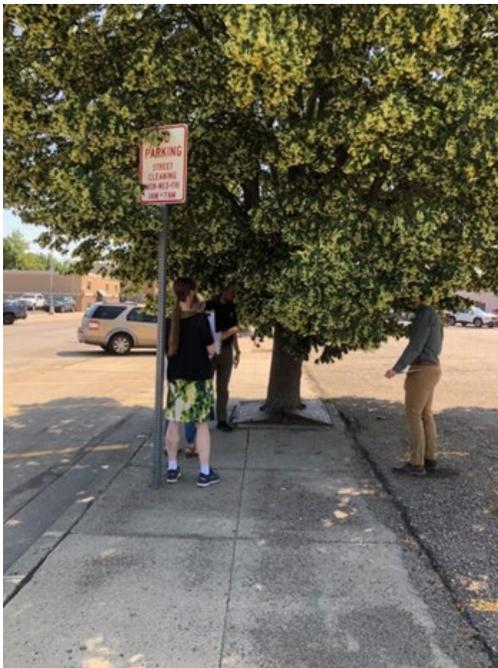
There are numerous driveways that intersect with the sidewalk along this stretch, and they are all level, with absence of any slope, which is highly desirable and lends to the walkability of the area. The boulevards are approximately 18-feet wide, providing an excellent buffer between the sidewalk and roadway, as well as providing an adequate area for sign or utilities placement, shade trees, and snow storage. It should be noted this residential area is one of Mandan's older neighborhoods and has recently seen an uptick in improvements made to homes and property. However, even if perceived as an improvement by the property owner, beautification elements (i.e., planters, etc.) should not be allowed to obstruct the public sidewalk, as shown in the photo (*right*). Additionally, fence placement should be located behind the sidewalk a minimum of 12 inches. Including such requirements in the City's ordinance if they do not already exist would assist with regulating and enforcing such best practices.

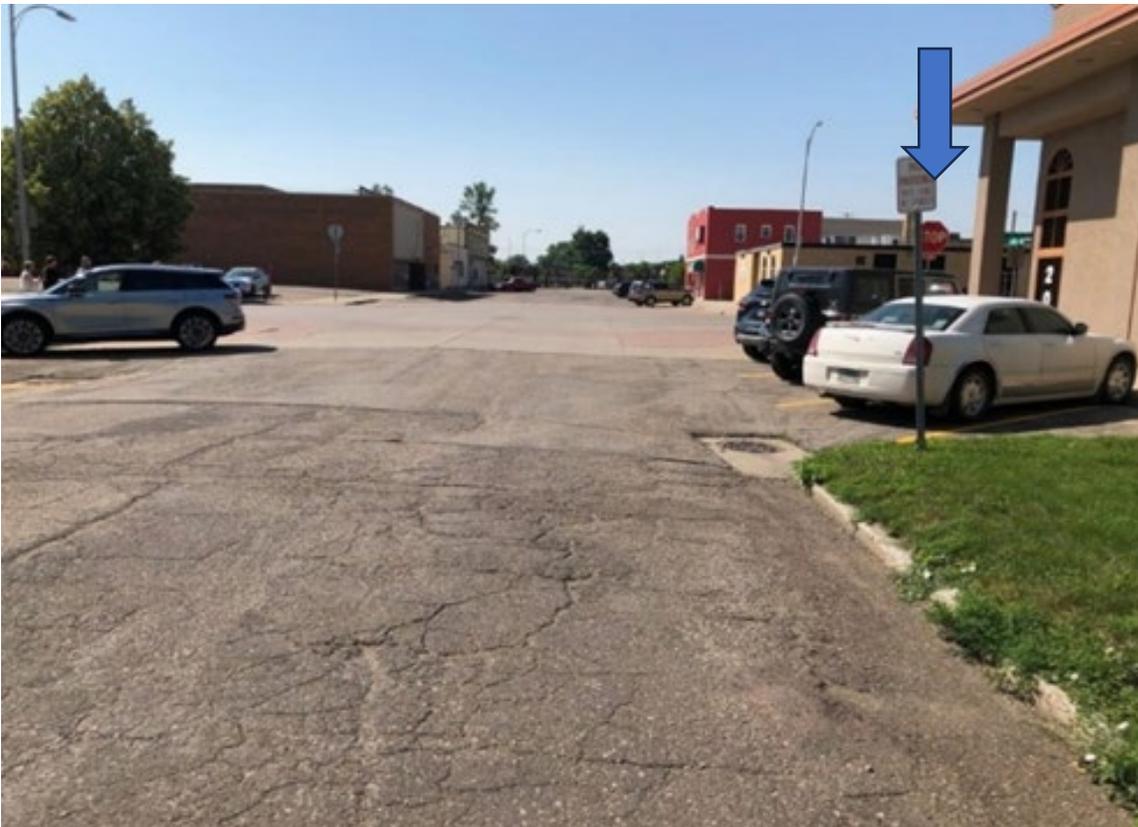
The photo below shows the stop sign placed well back from the roadway on the sidewalk, perhaps due to the diagonal parking. However, there have been pedestrian crossing improvements made to this intersection which include ADA ramps and colored pavement markings indicating bulb outs. Further improvements, such as raised curb bulb outs, would provide an area for stop sign placement within the bulb out which would increase motorist visibility of the stop sign and decrease the distance for pedestrians to cross the street.

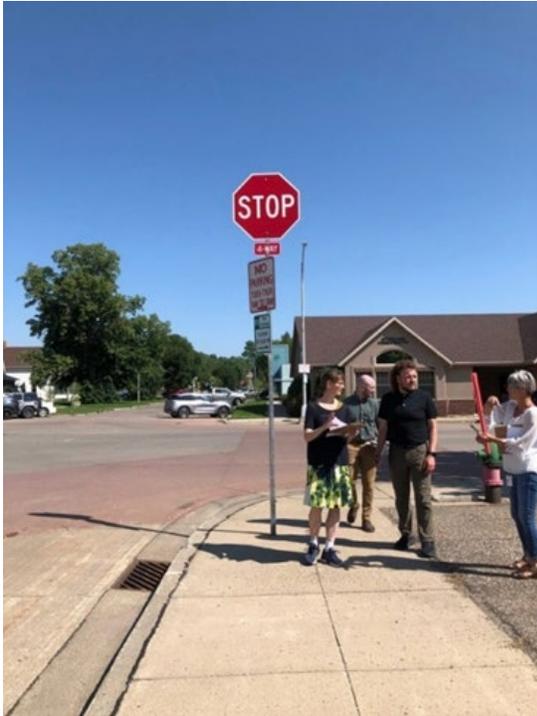
This photo (*left*) further illustrates the colored pavement crossing markings at the intersection of 4th Ave NW and 1st Street NW and the excellent condition of the sidewalk here. However, placement of a fire hydrant and traffic signs on the pedestrian sidewalk restrict use of its full width. Additionally, the Manual on Uniform Traffic Devices should be consulted to verify the height of this stop sign is not in violation.

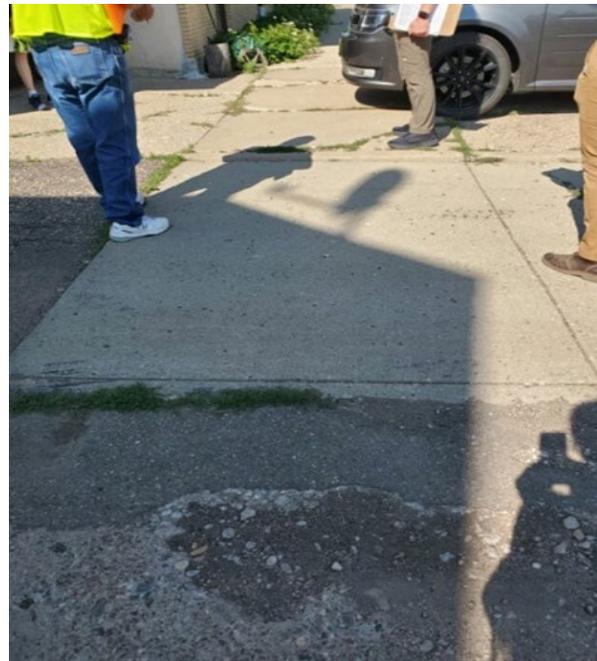
A mid-block ally (*photo below, right*) shows pavement degradation that has interrupted the walkability of this part of the route.

Further on (*also photo, right*) we saw weeds growing out from the building and restricting passage on the sidewalk, pushing pedestrians out to the curb which has diagonal parking abutting it. There is no barrier to prevent the vehicle from entering the sidewalk area. This restricts access and creates a safety hazard for pedestrians by moving vehicles.

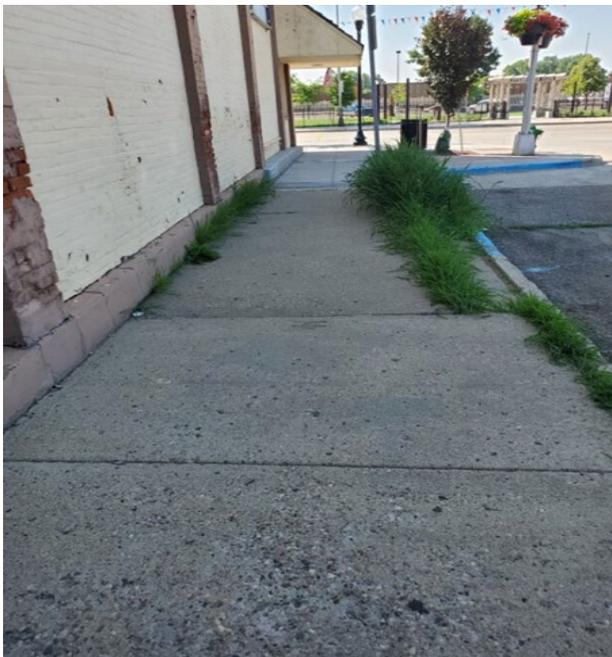
Another photo of the same building (*photo, left*) illustrates the weeds that have been allowed to overtake the curbside, completely obstructing access from the handicap accessible parking spaces adjacent to the sidewalk. (Note: City of Mandan stated they have received assurances from the property owner that all weeds will be removed.)

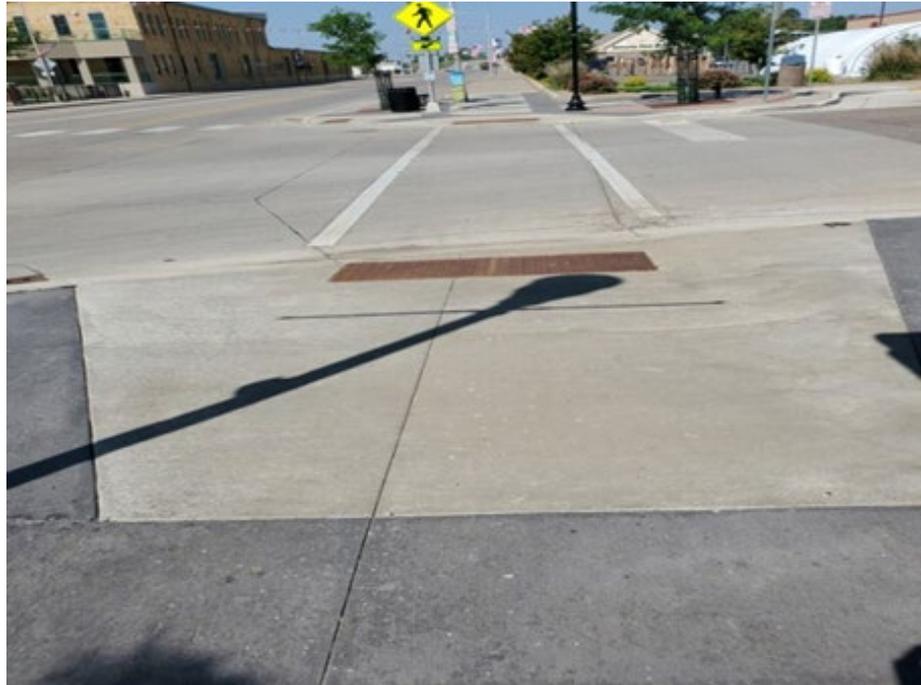
The sidewalk material at the corner of 4th Avenue NW and Main Street is consistent and in excellent condition, with no obstructions. *(Photo, right)* Garbage receptacles and pedestrian scaled lighting is located out of the primary transition areas for the pedestrian crossings.

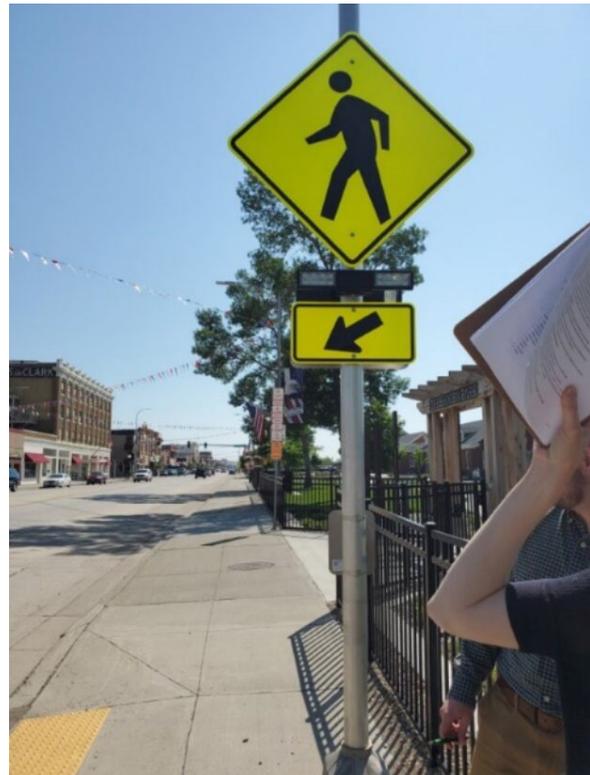
Pedestrian crossing improvements have been made here to include raised curb

bulb outs and ADA ramps with truncated dome pedestrian tiles at each crossing which is preferred over a central curb cutout shared by multiple direction crossings which face diagonally into the intersection. The raised curb bulb outs provide a sense of safety for the pedestrian against parking vehicles and reduce the distance required to cross the street. Additionally, the crossings are well marked and include a Rectangular Rapid Flashing Beacon, or RRFB. *(photo, left)* RRFBs are pedestrian activated crossing signals that feature two beacons and flashing lights to alert motorists to crossing pedestrians. The audible signal provided by the RRFB at the crossing on the west side of 4th Avenue crossing south to Main Street is audible from several feet away from the speaker. And finally, as part of the RRFB, there is highly visible signage and flashing lights at the location of the crossing. The lights flashed long enough to easily complete the crossing. All these elements serve to make the pedestrian crossing experience non-threatening and accomplished with ease.

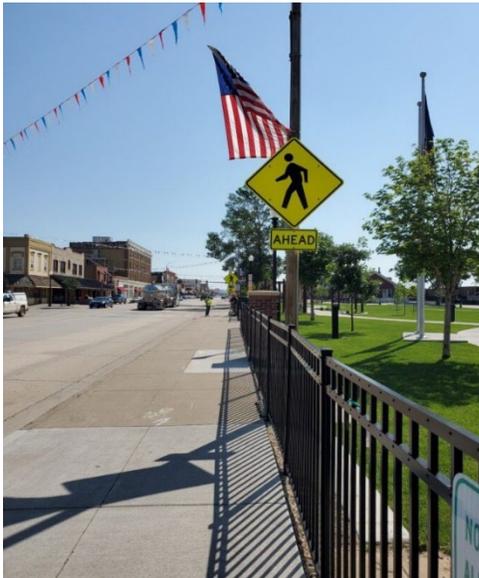
Signage alerts motorists well in advance of impending pedestrian crossings. (*below, left*) The

sidewalk, which is concrete throughout, is in very good to excellent condition, free of cracks, chips, or uneven slabs. At 8-feet, it is wide enough to be used as a multi-use path. It is separated from the interior public space by a fence, with shaded seating areas and utilities (i.e., fire hydrants) in recessed areas so they are set back from the sidewalk/multi use path. This offers a safe resting place, limiting potential conflict with those who may be walking or rolling on the sidewalk. The seating areas are shaded by trees planted inside the public space, away from the sidewalk, keeping the sidewalk free from obstructions and less susceptible to the heaving frequently caused to concrete by tree roots.

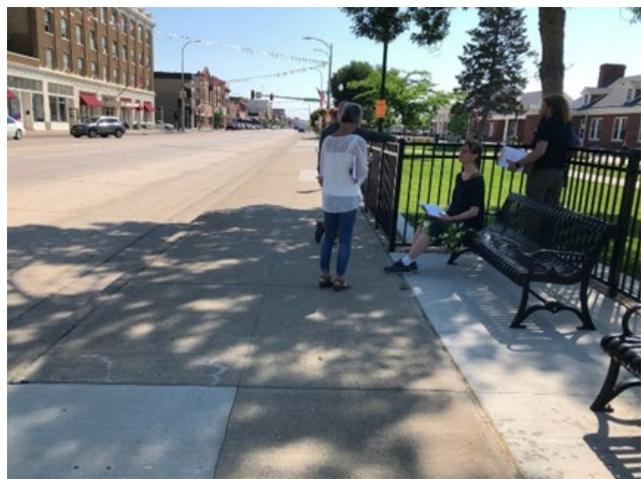
We found this to be a very pleasant and walkable area. In addition to benches, there are other enhancements such as pedestrian scaled lighting, graphic-wrapped utility boxes, decorative garbage receptacles, bike racks, planters and hanging baskets of flowers lining both the north and south sides of the street, all of which add to the aesthetic value of the area. This segment presents an excellent demonstration of best practices in creating walkable environments.

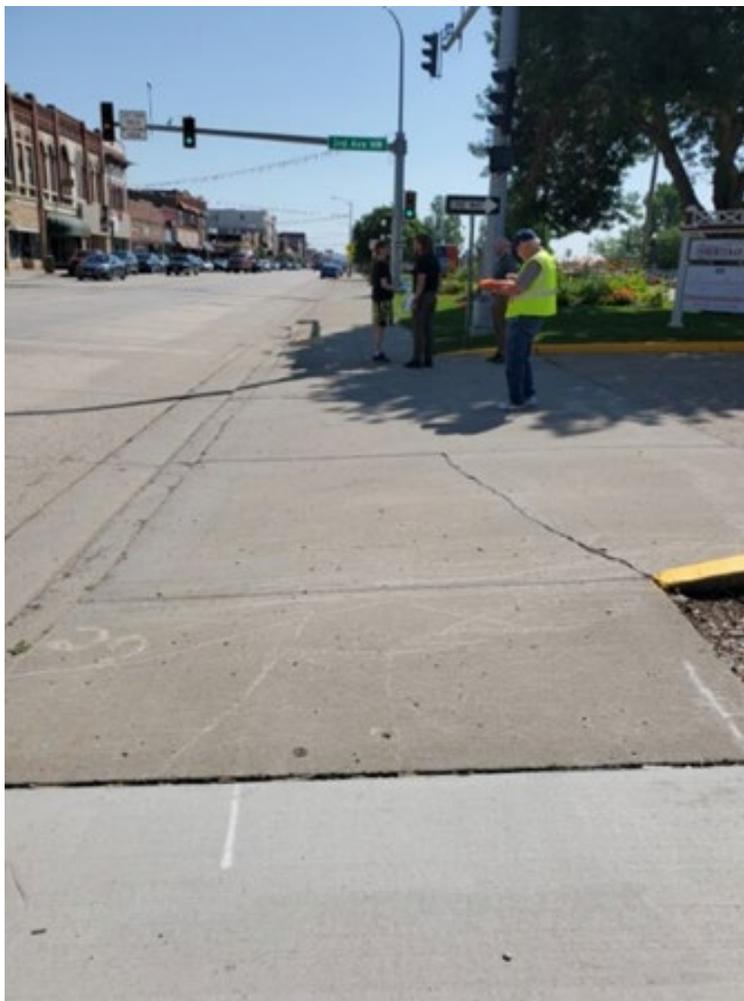
While Main Street represented the segment of the walk audit most improved since the 2017 assessment, there is still a challenge or two that remains. The driveway entrance to Heritage Plaza is located on the south side of the intersection of Main Street and 3rd Avenue NW.

(Photo, right) The concrete, although older, is still in good condition with the exception of the crack that extends the width of one side of the driveway. There is a slope to the driveway, rather than being level with the sidewalk. The width of the sidewalk and the fact that one side abuts the roadway, presents some challenges in achieving a no slope status to this driveway intersection. Additionally, this is a one-way driveway into the Plaza from either Main Street or 3rd Avenue NW, and intersection geometry, along with the location of the pedestrian crossing on the east edge of this driveway present safety concerns. City staff stated there have been conversations to convey this concern to the Plaza.
