BISMARCK WALKABILITY ASSESSMENT 2024

FINAL REPORT

JULY 2025

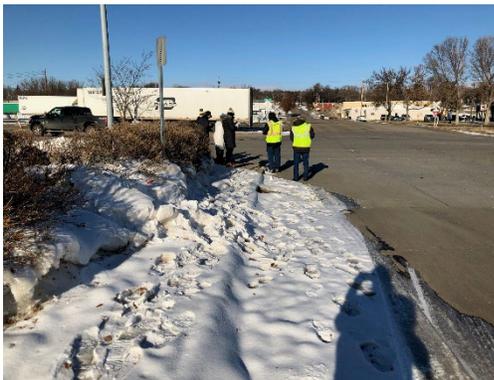
The roadway comprising this intersection (24th Street) is bi-directional with 1 southbound driving lane and 1 northbound driving lanes.

The speed limit is 25mph and traffic crossing Main Avenue on 24th Street is governed by a stop sign. The crossing area is wide (there is on-street parking to the south) and there is no center median, pedestrian island, or bicycle facility in place. The sidewalk in this area is narrow, and pedestrian movement is further impeded by a stop sign (*photo, right*) on the east side of 24th, and overgrown bushes on the west side. The sidewalk on the east side of 24th was relatively clear of snow, but on the west side the sidewalk was covered (*photo, left*). Numerous footprints were visible in the snow, showing pedestrian use. There are currently no ADA ramps, signs, or crosswalk striping at this crossing. The curb cut ramps show signs of significant wear.

Considerations for pedestrian crossing improvements should include, at minimum, high visibility crosswalk markings, ADA ramps, and the potential addition of pedestrian actuated/audible signal crossing signals. If a reconfiguration of the roadway or reconstruction is planned for this intersection, raised curb bulb outs or a pedestrian island should be considered to reduce the crossing distance and provide a safer and less intimidating pedestrian experience. Improved snow storage (*photo, right*) should also be a consideration.

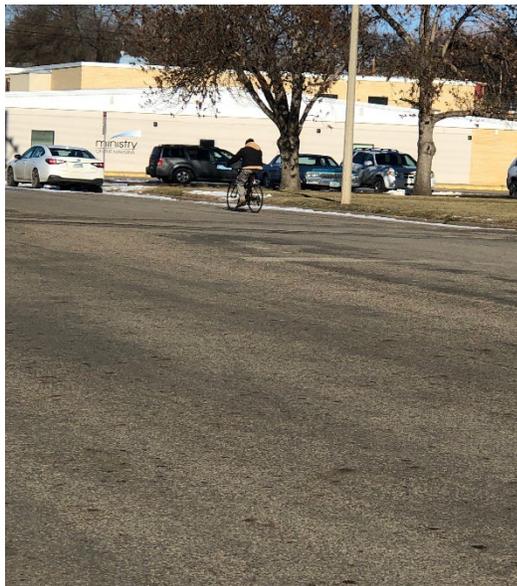
Main Avenue is bi-directional with 2 eastbound and 2 westbound driving lanes, and a center turn lane. The posted speed limit is 35 mph. There are no bicycle facilities here (a bicyclist was

observed crossing Main Avenue, *photo left*). There is a motel to the west of the crossing on the south side, and an industrial gravel lot adjacent to the north side of the crossing. The sidewalk ends a short distance north along the west side of 24th and is impeded to the west by a tree planted in the middle of the sidewalk. The curb cut ramps are worn, and the sidewalks narrow. The crossing itself is uncomfortably wide, with no visible crosswalk, pedestrian signage, or other pedestrian infrastructure in place. Footprints in the snow (*photo left, page 3*) and participant observations suggest this is a highly utilized pedestrian crossing.

Pedestrian improvements at this intersection should include the same items noted at the 24th Street Intersection.

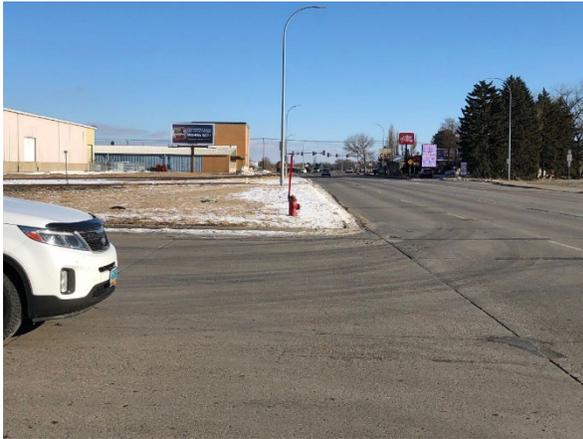
As noted on the previous two segments, the crossing here is uncomfortably wide and lacks any

kind of crosswalk or other pedestrian infrastructure. On the west side the sidewalk is worn and narrow and ends abruptly a short distance to the north. There are no sidewalks on either side of 24th Street between Main Avenue and Broadway Avenue. On the east side, there is no sidewalk along either 24th Street or Main Avenue (*photo, left*).

Pedestrian improvements at this intersection should include the considerations noted for the previous two intersections. Additionally,

completing the sidewalks on both sides of 24th between Main Avenue and Broadway Avenue would be advisable.

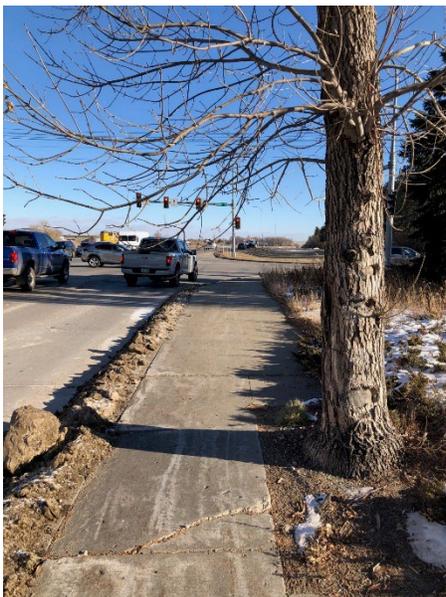
This segment of roadway provides a sidewalk, averaging about 6' in width, that has signs of wear. There is a drive-through restaurant (Big Boy) located along this segment, accessible by eastbound motorists directly off Main Avenue. There is a dedicated right turn lane, about 175 feet long, provided for Big Boy on Main Avenue. An Auditor noted this lane is not long enough during peak dining hours, leading to traffic stacking on the outside driving lane on Main.

There is a tree immediately west of the 26th Street intersection (*photo, left*) that impedes the sidewalk and creates a potential hazard for pedestrians. The crossing at the Big Boy drive-through lane is at an awkward southwest angle, and it is not marked. A good section of the sidewalk

Recommended pedestrian improvements along this segment would include trimming the tree west of 26th Street, removing signage in the path of pedestrians, and improving the Big Boy drive-through lane crossing.
