# MANDAN WALKABILITY ASSESSMENT 2024

## FINAL REPORT

JULY 2025

PREPARED BY:  
STEPHEN LARSON  
BISMARCK-MANDAN METROPOLITAN PLANNING ORGANIZATION  
BISMARCK, ND

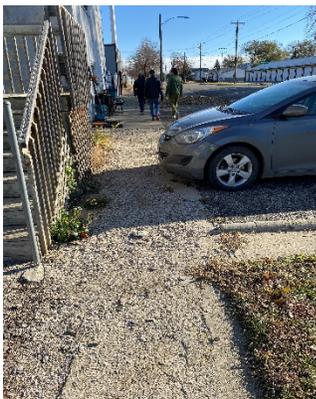
The roadways comprising this intersection are bi-directional with two driving lanes. The speed limit is 25mph and traffic crossing 3<sup>rd</sup> Street is governed by a stop sign. The sidewalk in this area is only about 4' wide and shows significant wear (*photos, right & left*). Parked cars and railings further narrow the path.

Considerations for pedestrian crossing improvements should include, at minimum, crosswalk markings, installation of sidewalk and ADA ramps on the north and south sides of 3<sup>rd</sup> Street, and repairs to existing sidewalk.

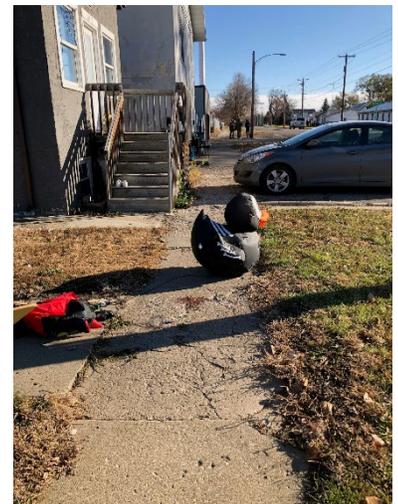
ADA ramps are provided on both the north and south sides of 3<sup>rd</sup> Street, crossing 7<sup>th</sup> Avenue. However, there are no marked crossings, ADA ramps, or connecting sidewalks crossing 3<sup>rd</sup> Street from either the north or south sides of 7<sup>th</sup> Avenue. The stop signs at this intersection are placed ahead of the crosswalks, instead of before them, which could lead to cars stopping in the pedestrian right-of-way.

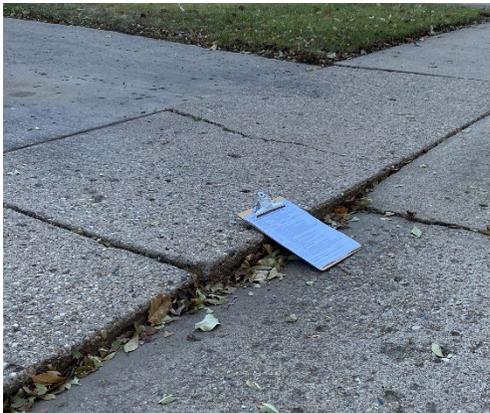
The 8<sup>th</sup> Avenue Intersection is in a school zone with a marked speed limit of 15mph when children are present. Mary Stark Elementary is located just west of 8<sup>th</sup> Avenue. The south side of 3<sup>rd</sup> Street between 7<sup>th</sup> and 8<sup>th</sup> is residential with an alley

access. In general, the sidewalk in this area was in decent condition, with some wear. However, it was occasionally narrowed by overgrowth (*photo, right*) and parked cars. Also, there was a drop off between the edge of the sidewalk and the driveway at 805 3<sup>rd</sup> Street SW (*photo, left*).

Pedestrian improvements at this intersection would involve replacing the missing ADA ramp, addressing any worn-out sidewalk, and potentially working with Mandan Public Works to address overgrowth.

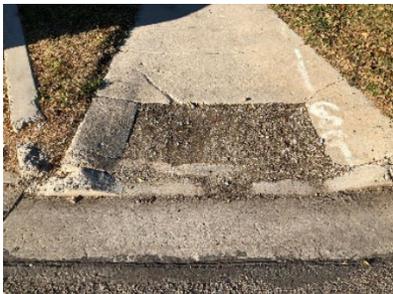
The crossing of 8<sup>th</sup> Ave SW towards the school was clearly marked, governed by all-way stop signs, and had ADA ramps, except for a missing ramp on the west side of 8<sup>th</sup> (*photo, below left*).

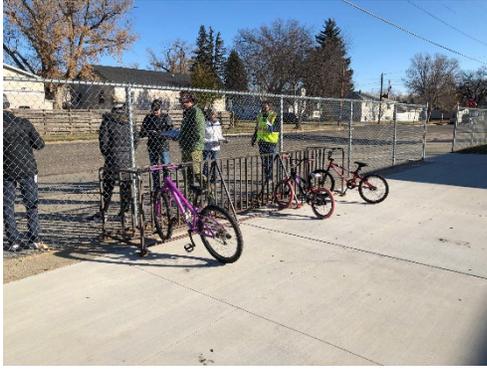
The sidewalk in this area is generally clear and in good condition. A large section of the south side of 3<sup>rd</sup> Street between 8<sup>th</sup> and 9<sup>th</sup> is taken up by a bus loading zone (including 3 ADA ramps) for Mary Stark. The school is fenced and provides bike parking (*photo, left, page 5*). The intersection of 3<sup>rd</sup> and 9<sup>th</sup> has marked crosswalks on 3 of 4 crossings (only the north side of 3<sup>rd</sup> crossing 9<sup>th</sup> is unmarked) and governed by all-way stop signs. The southeast corner of 3<sup>rd</sup> and 9<sup>th</sup> has curb cut ramps instead of ADA ramps, and these show signs of wear. The other corners

of the crossing have ADA ramps. Installing ADA ramps here and marking the crossing of 9<sup>th</sup> Avenue on the north side of 3<sup>rd</sup> would be possible improvements for pedestrians at this intersection.

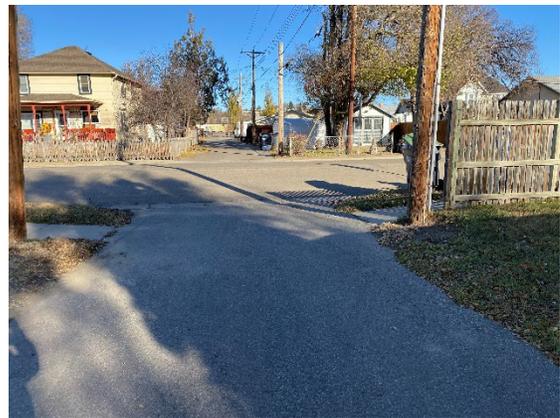
The south side of 3<sup>rd</sup> Street between 9<sup>th</sup> and 10<sup>th</sup> is residential with an alley access, and a small church (Mandan Baptist) on the corner of 3<sup>rd</sup> and 10<sup>th</sup> (with a small parking lot accessible through the alley). 10<sup>th</sup> Avenue is a bi-directional roadway with a northbound and a southbound driving lane, with on-street parking on both sides of the road and a posted speed limit of 25mph. It was observed that northbound vehicles coming out of the alley have their vision obstructed by fencing (*photo, right*). The slope of the sidewalk down to the alley is also somewhat steep, and the sidewalk was worn in places.

The 10th Avenue Intersection is governed by stop signs at either side of 3<sup>rd</sup> Street. The crossing of 10<sup>th</sup> Avenue is wide, and there are no marked crosswalks. There are at this crossing on the southeast, northeast, and northwest corners of the intersection, but there is no crossing or sidewalk of any kind at the southwest corner of 10<sup>th</sup>. The ADA ramps on both sides of the crossing of 3<sup>rd</sup> Street (the southeast and northeast corners) are oddly angled and could lead a visually impaired pedestrian out of the intersection and into the street.

Correcting the angles of the ADA ramps crossing 3<sup>rd</sup> Street, fixing worn sidewalk along 3<sup>rd</sup> Street, installing sidewalk on the west side of 10<sup>th</sup>, and considering marked crossings of 10<sup>th</sup> Avenue (if reconstruction were to take place, pedestrian medians or curb bulb-outs would be features to consider) are all possible improvements that would be valuable for this segment.

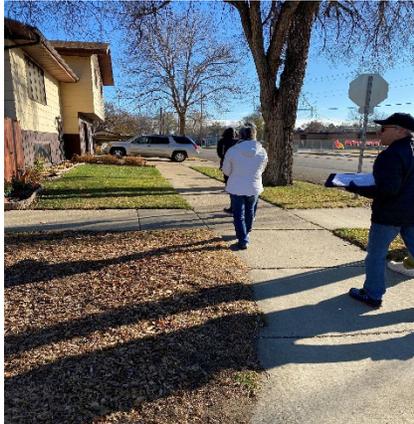
The north side of 3<sup>rd</sup> along this segment is residential. There were difficulties traversing the sidewalk here, with extensive deterioration of the concrete at many points (*see photos, page 3*). Some fences were built right up to the sidewalk, reducing operating width, and the sidewalk

was often too narrow to be accessible to pedestrians with mobility challenges. From 10<sup>th</sup> Avenue to 9<sup>th</sup>, the sidewalk is adjacent to the street curb. The setback of the house at 908 3<sup>rd</sup> Street SW meant the resident had to park across the sidewalk (*photo, left*). The northern crossings were in good condition (*photo, right*) with ADA ramps, but the crossings were unmarked.

Sidewalk repairs and marked crossings would be improvements for this segment. Existing geometric challenges would be more difficult to address, which is why newer developments should follow best practices for setbacks, sidewalk width, etc.

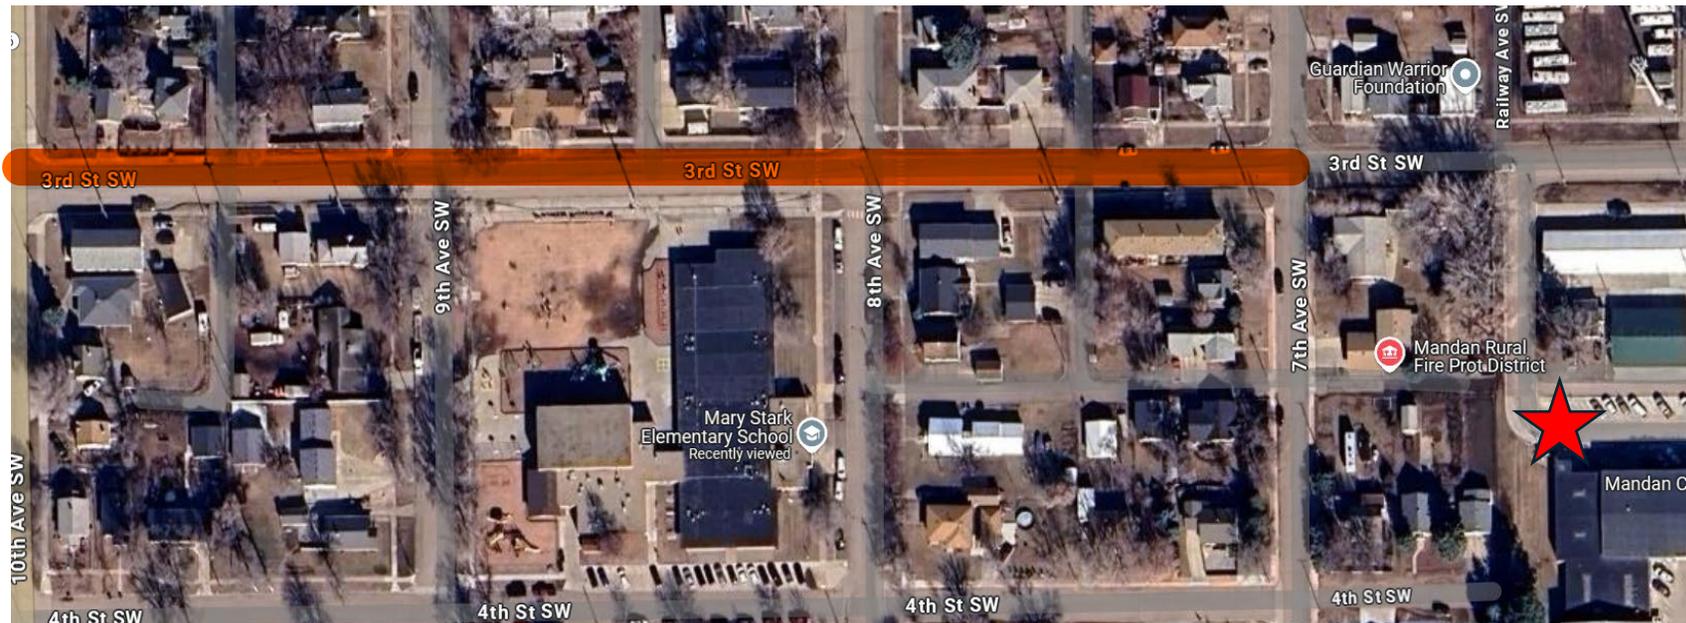
This map shows the location of the Public Works Building (marked with a red star). Enter onto Railway Avenue SW from 3<sup>rd</sup> Street SW to access parking and the main door of the building. We will meet inside to review audit materials and procedures.

The map also shows the audit route area along 3<sup>rd</sup> Street SW in orange. We will audit from the intersection of 7<sup>th</sup> Avenue SW and 3<sup>rd</sup> Street SW to the intersection of 10<sup>th</sup> Avenue SW and 3<sup>rd</sup> Street SW. The audit will include both the north and the south sides of 3<sup>rd</sup> Street SW.
